The Major Cause of Earthquake Disasters: Shear Bandings

Tse-Shan Hsu

Abstract

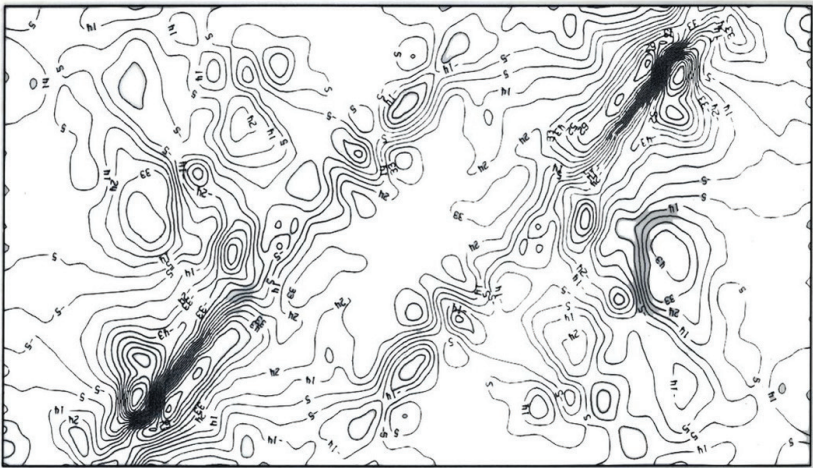
During shear banding, excess pore water pressure is highly concentrated in a shear band, as shown in **Figure 2**. In addition, repeated stick-slip phenomena will be induced, as shown in **Figure 3**. When the sticking action continues to raise the friction resistance up to the maximum value of the static friction resistance, the sticking phenomenon will then change to slipping. At this point in time, the friction resistance changes from static friction to kinetic friction. While the slipping action continues until the sticking reappears, the friction resistance will drop to the minimum value of the kinetic friction resistance. Thereafter, the static friction resistance will increase again. When the stick-slip phenomenon repeatedly appears in shear bandings, and the

Figure 2. Contours of excess pore water pressures related to **Figure 1b** [8].

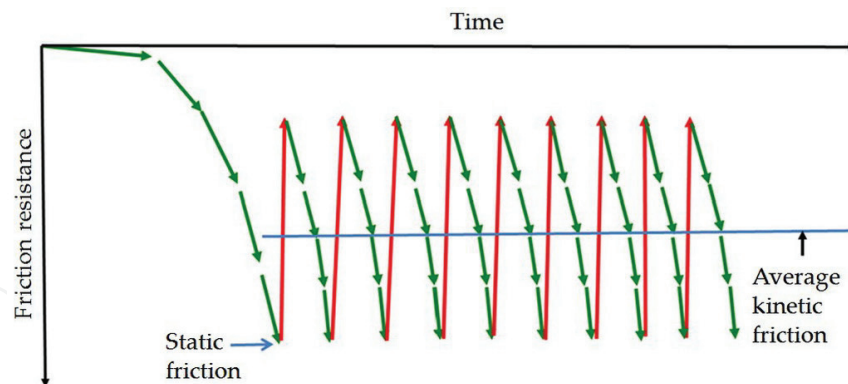
Figure 3. Stick-slip phenomenon in shear banding (modified from [9]).

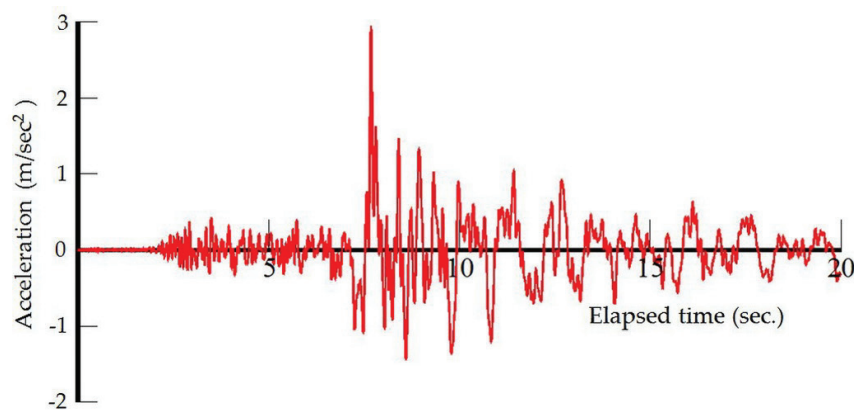
Figure 4. Seismometer record of the ground acceleration time-history curve.

state changes from sticking to slipping, the shear banding will accelerate; conversely, when the state changes from slipping to sticking, the shear banding will decelerate. Therefore, in shear banding, the ground acceleration time-history curve, as shown in **Figure 4**, can be recorded by a seismometer installed on the ground surface.

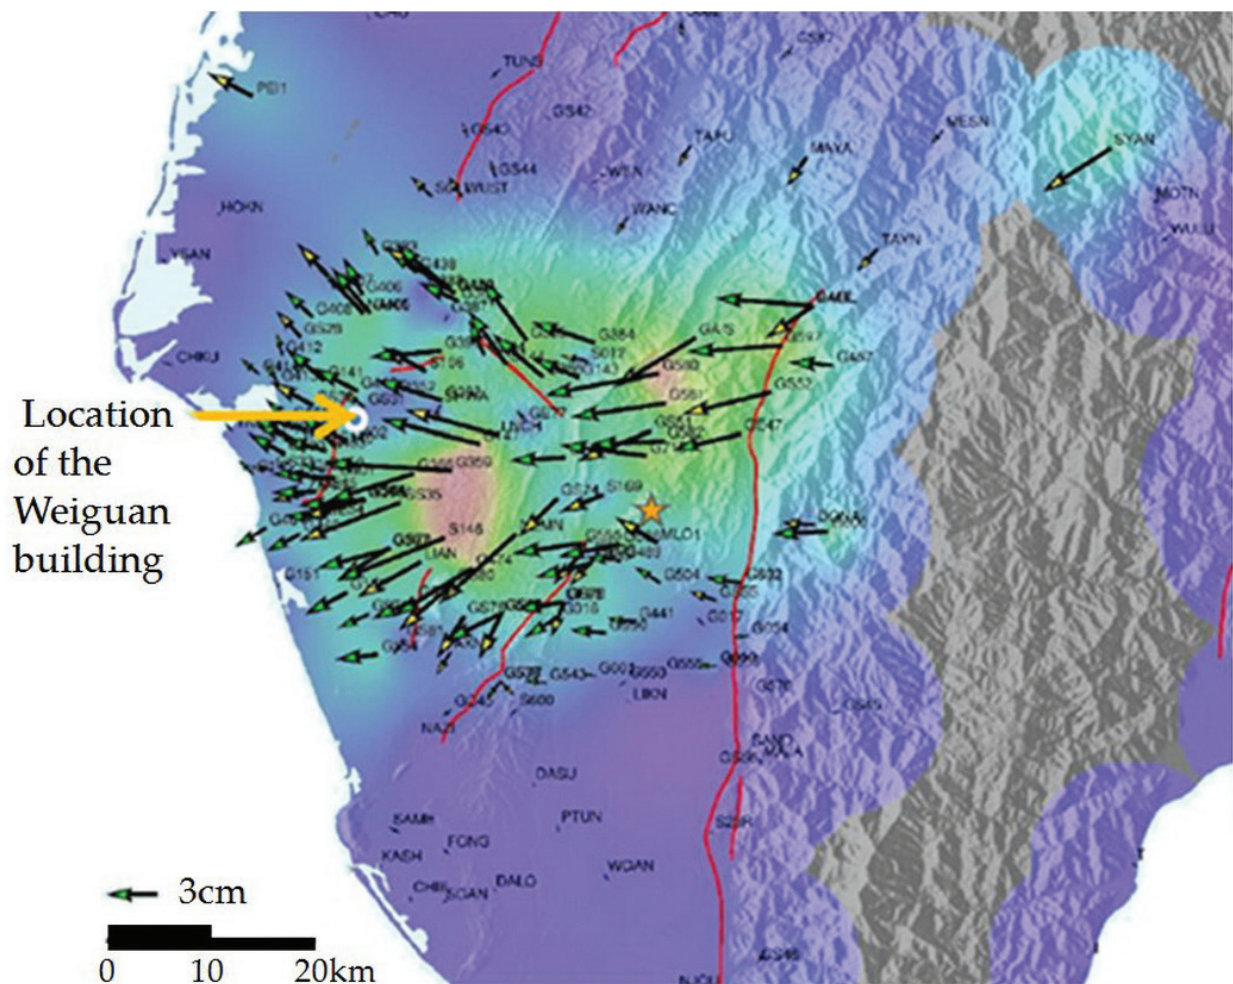
Step 2: The GPS velocity vectors shown in **Figure 11** indicate that shear banding did occur near the Weiguan building. The pipe burst is another piece of evidence for shear banding.

Note, however, that such a shear banding phenomenon did not occur during the 2010 Jiasian earthquake.

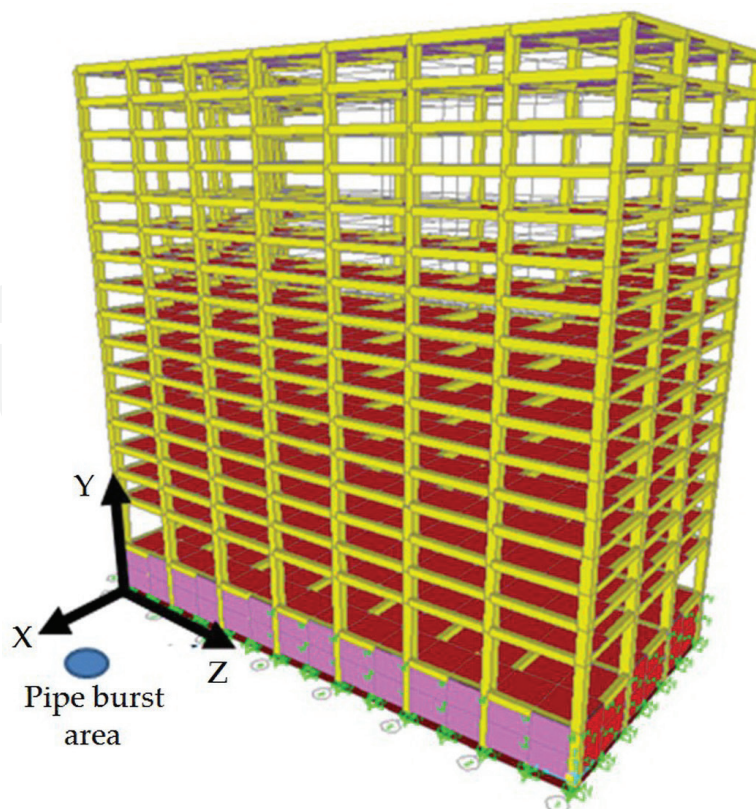
Figure 12. The structural model used in the dynamic analyses.

A structural model of the whole building, including all elements of both the upper and the lower structures, is used, as shown in **Figure 12**. It is important to mention that the cross sections and material properties used in the analyses are similar to those adopted by the original designer. The side walls surrounding the basement are constrained by springs, with their elastic modulus determined by values of N from standard penetration tests. When the pipe burst is to be considered (or not considered), the springs for the side walls near the pipe burst area are removed (or not removed), such that the effect of shear banding can be determined numerically. The loading conditions included both static loads and seismic vibration forces; the static loads include a live load 200 kgf/m^2 and a dead load 150 kgf/m^2 , in addition to the body forces of the structural elements. The seismic vibration forces are generated by the acceleration history taken from Station No. CHY063, as shown in **Figure 13**.

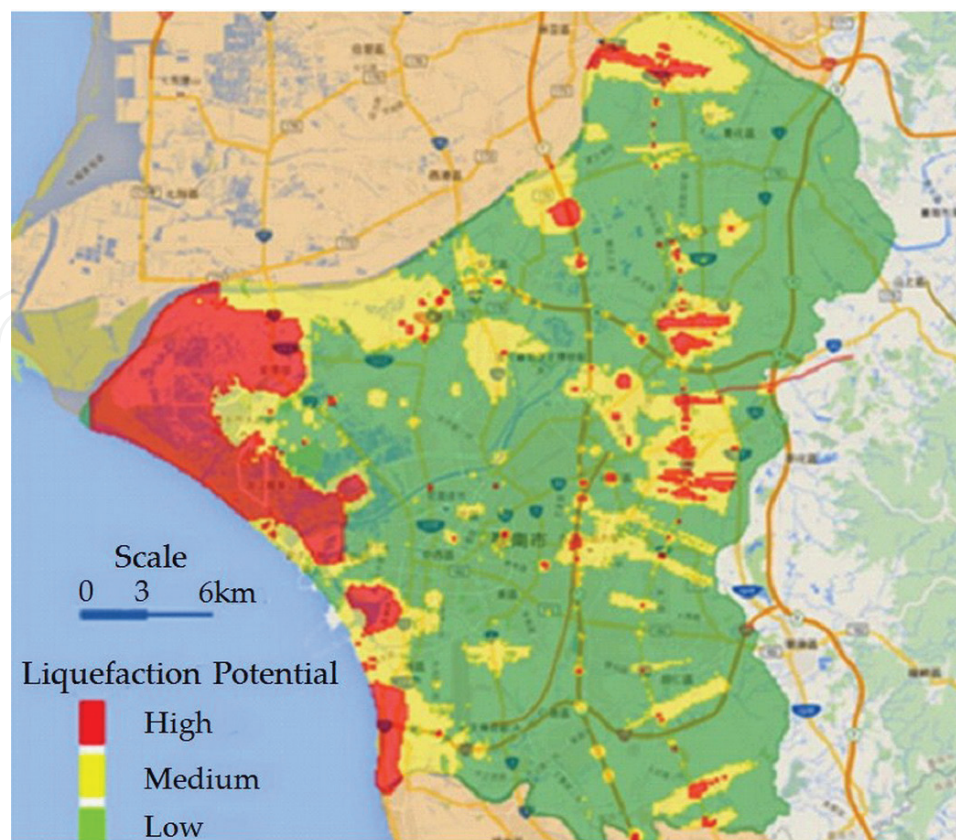
The actual location of soil liquefaction in Tainan City took place during the Meinong Earthquake on February 6, 2016, as shown in **Figure 16**. **Figure 16** also shows that: (1) soil liquefaction is

merely a kind of localized phenomenon; (2) the actual area of soil liquefaction is far less than the area of conventional soil liquefaction potential proposed by the Central Geological Survey, MOEA; and (3) the actual locations of soil liquefaction were mostly outside the areas with high liquefaction potential. Thus, we know that the conventional cause of soil liquefaction is different than the cause of localizations of soil liquefaction.

Figure 16. Comparison between the locations of soil liquefactions induced by the Meinong earthquake and the distribution of conventional liquefaction potential [8, 19].
